Assessing Sedimentation Issues within Aging Flood Control Dams, Oklahoma

By Sean J. Bennett and Charles M. Cooper

Research Report No. 15

A preliminary report prepared for the USDA-NRCS, Stillwater, OK

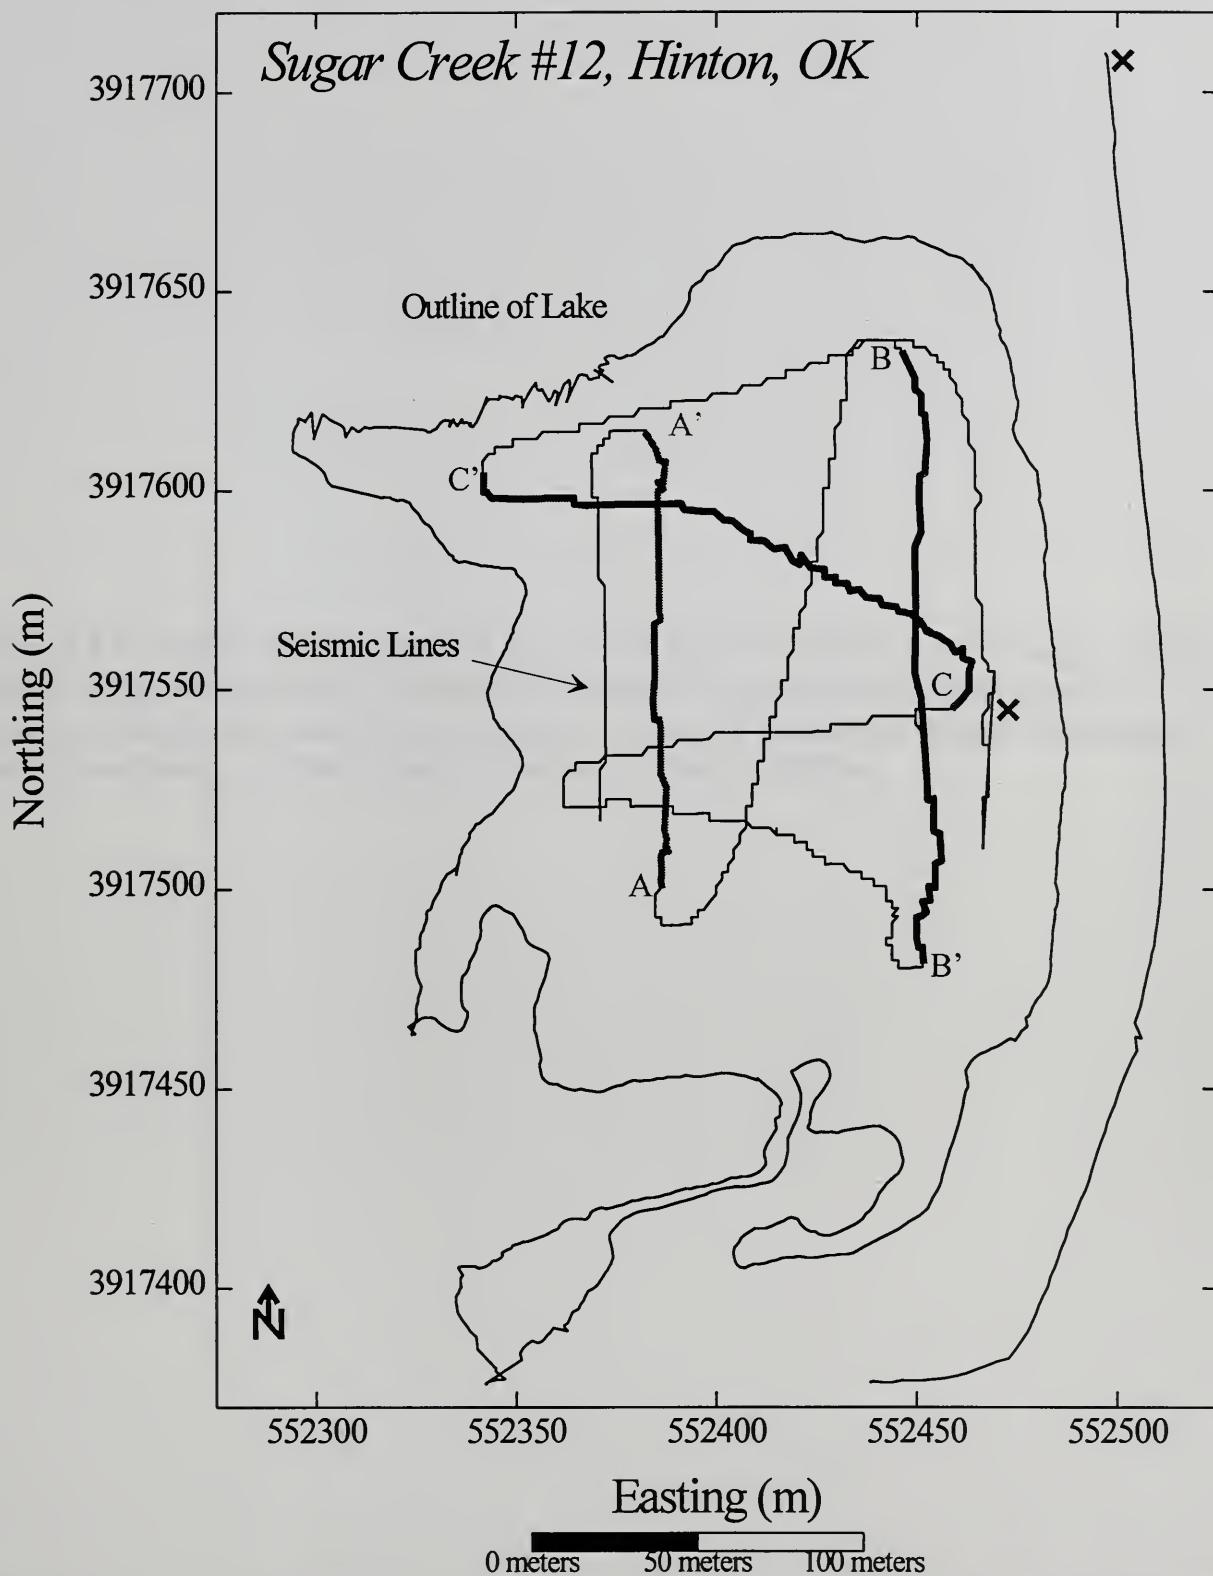
Figure 3-5. Base map of Sugar Creek #12 showing traces for all seismic lines. Three segments, labeled A-A', B-B', and C-C', are discussed in text. All positions are in UTM coordinates.

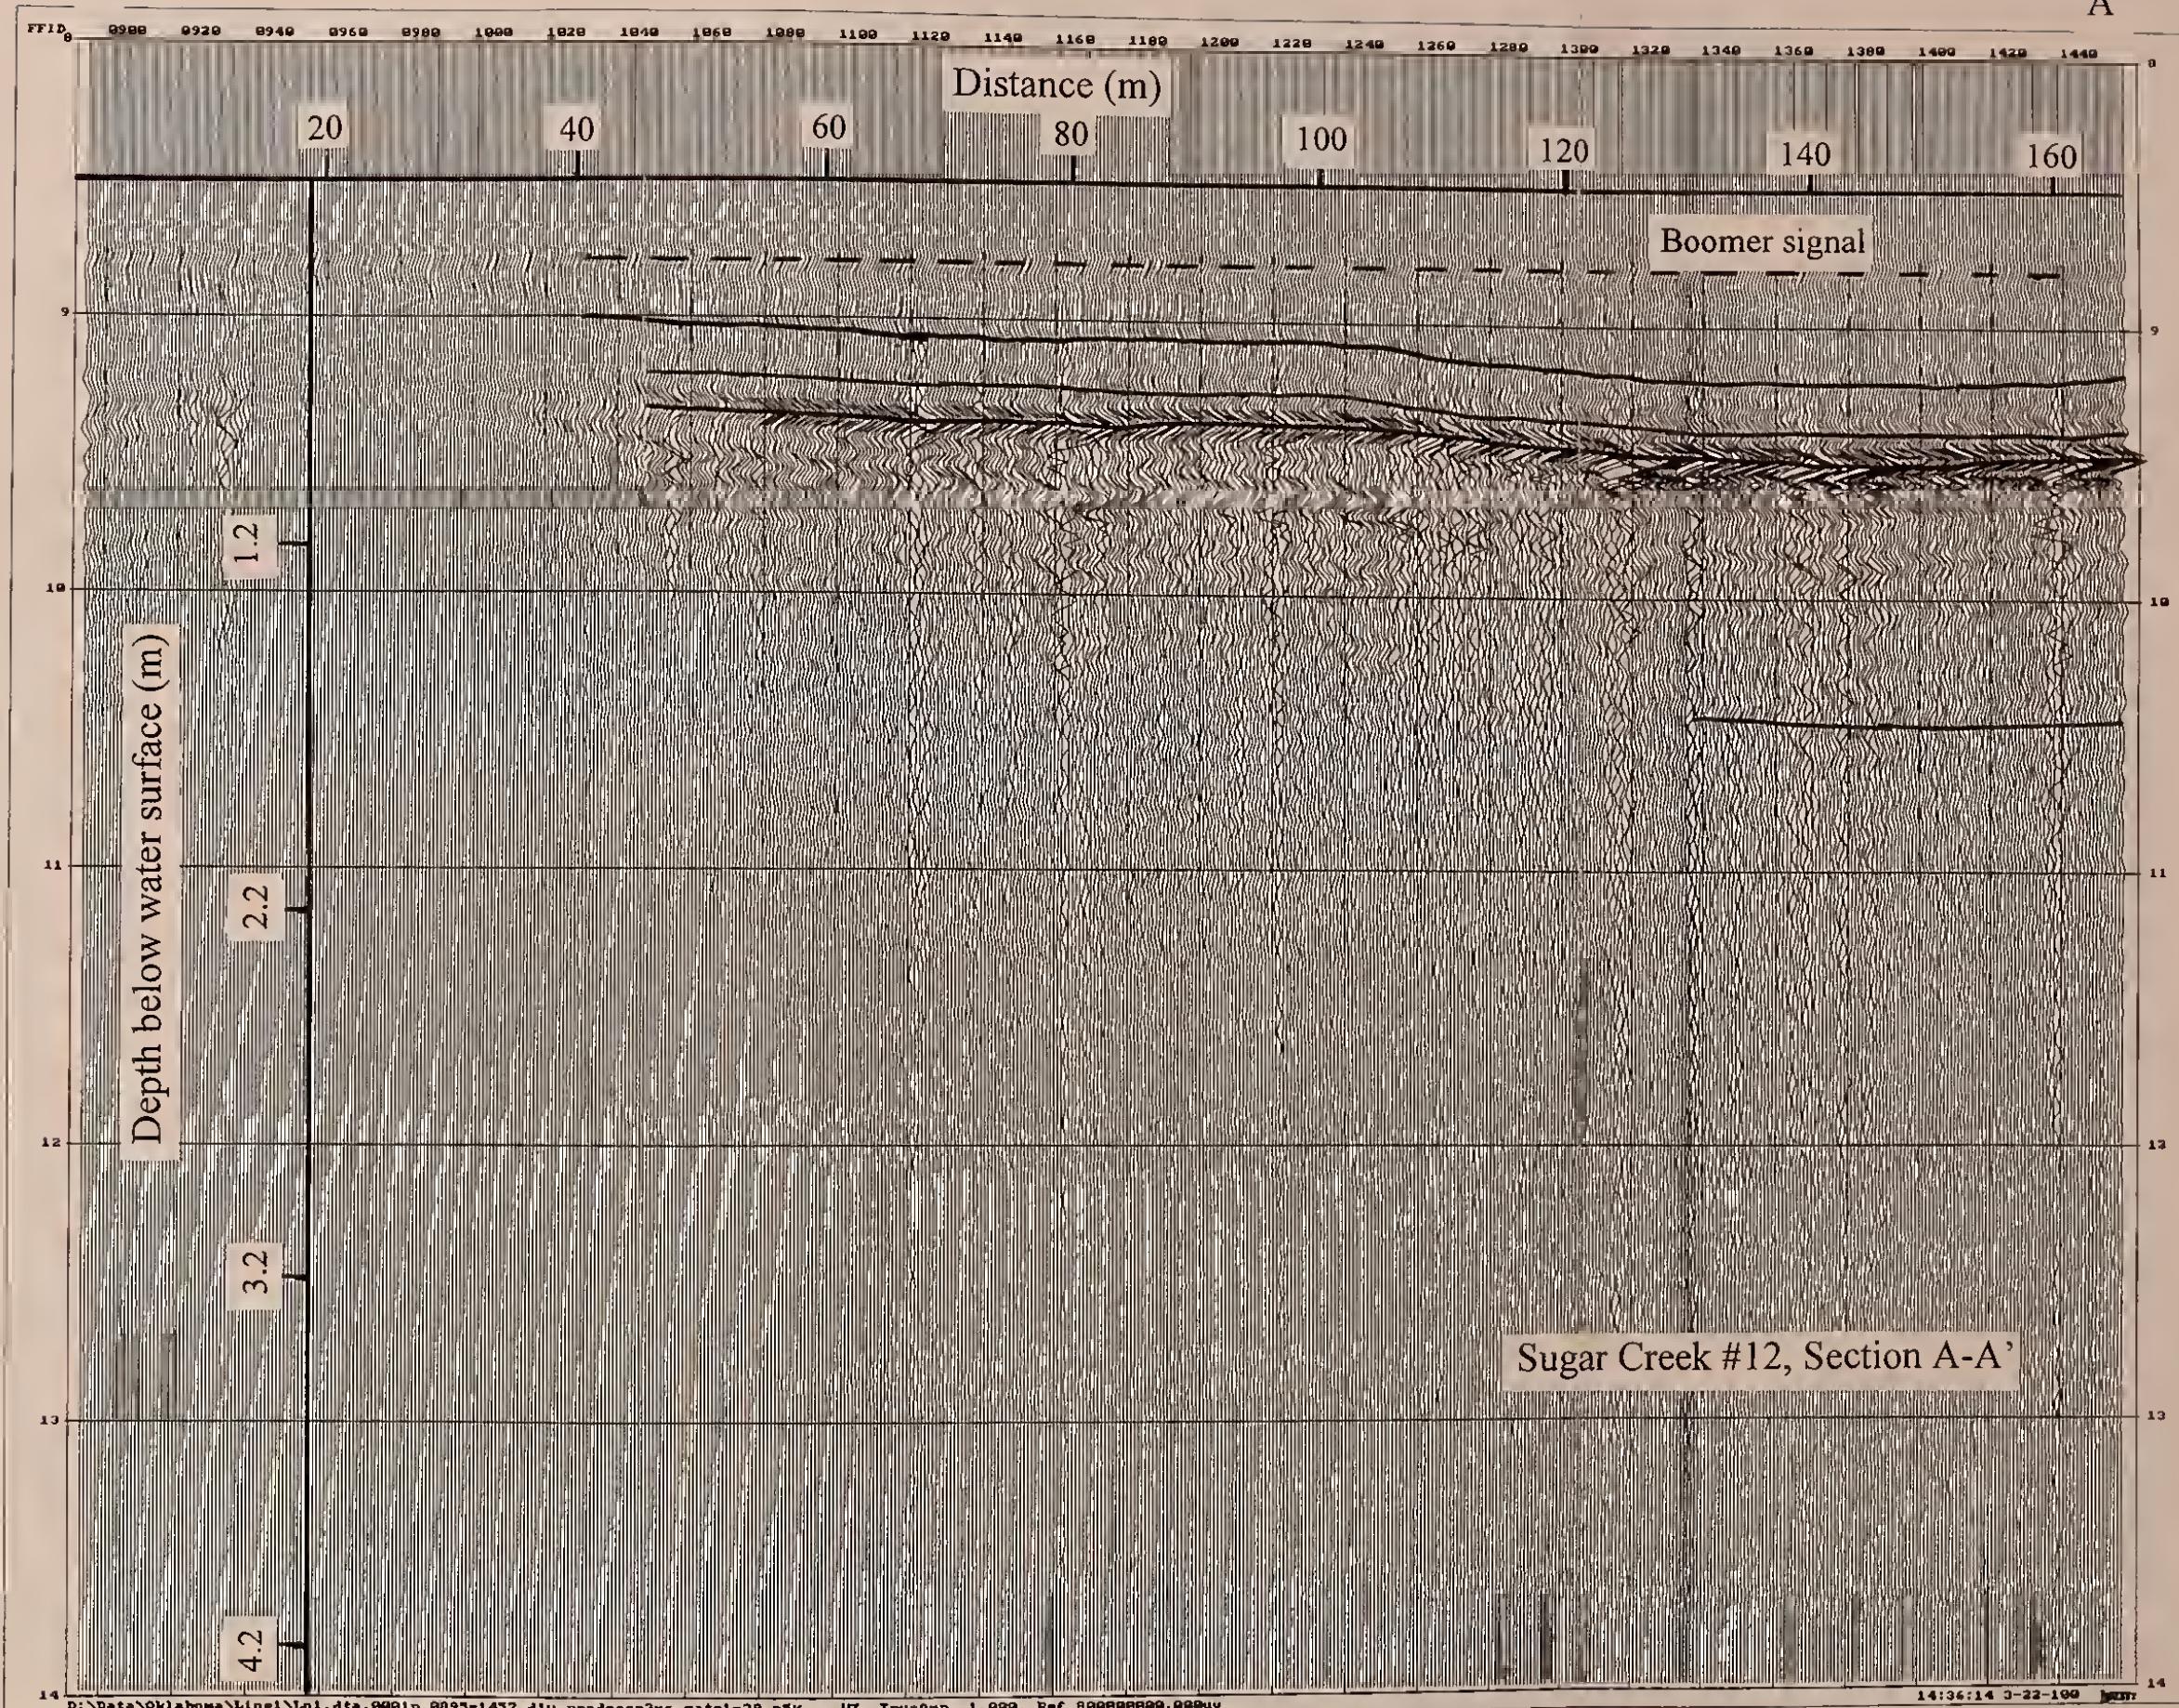
In general, the following observations can be made. The sediment near the water-sediment interface is quite soft, and it is represented by weak or low-amplitude reflectors (Figure 3-6, 3-7, and 3-8). The thickness of this reflector is about 0.15 to 0.2 m and it does not vary in thickness across the basin. However, this reflector does appear to thicken towards the southern part of the lake (towards B'; see Figure 3-7). At a depth of approximately 0.4 m, a very strong seismic reflector is observed, and this reflector is ubiquitous in all the seismic records. This strong seismic reflector caused most of the seismic reverberations due to its strong seismic properties and its close proximity to the water surface and seismic receiver. Again, this seismic reflector is observed basin wide, and may represent a change in sediment composition such as a sand or gravel layer, a change in sediment density such as variation in mineralogy or relative compaction, have a biological origin, or represent some kind of hard-pan. Because this reflector has such strong seismic characteristics, it is difficult to observe any deep horizons, although some were delineated (see Figures 3-6 and 3-7). These deeper horizons occur at a depth of approximately 0.9 to 1.1 m, respectively, and it is approximately 0.1 m thick. At present, the reason for this deep reflector is unknown.

Figure 3-6. Seismogram of section A-A' from Sugar Creek #12 (next page; refer to Figure 3-5). Dashed line is location of boomer (approximately 0.5 m below the water surface), and solid lines are seismic reflectors identified. Depth and length scales are shown, and total length of seismic record is 162 m.

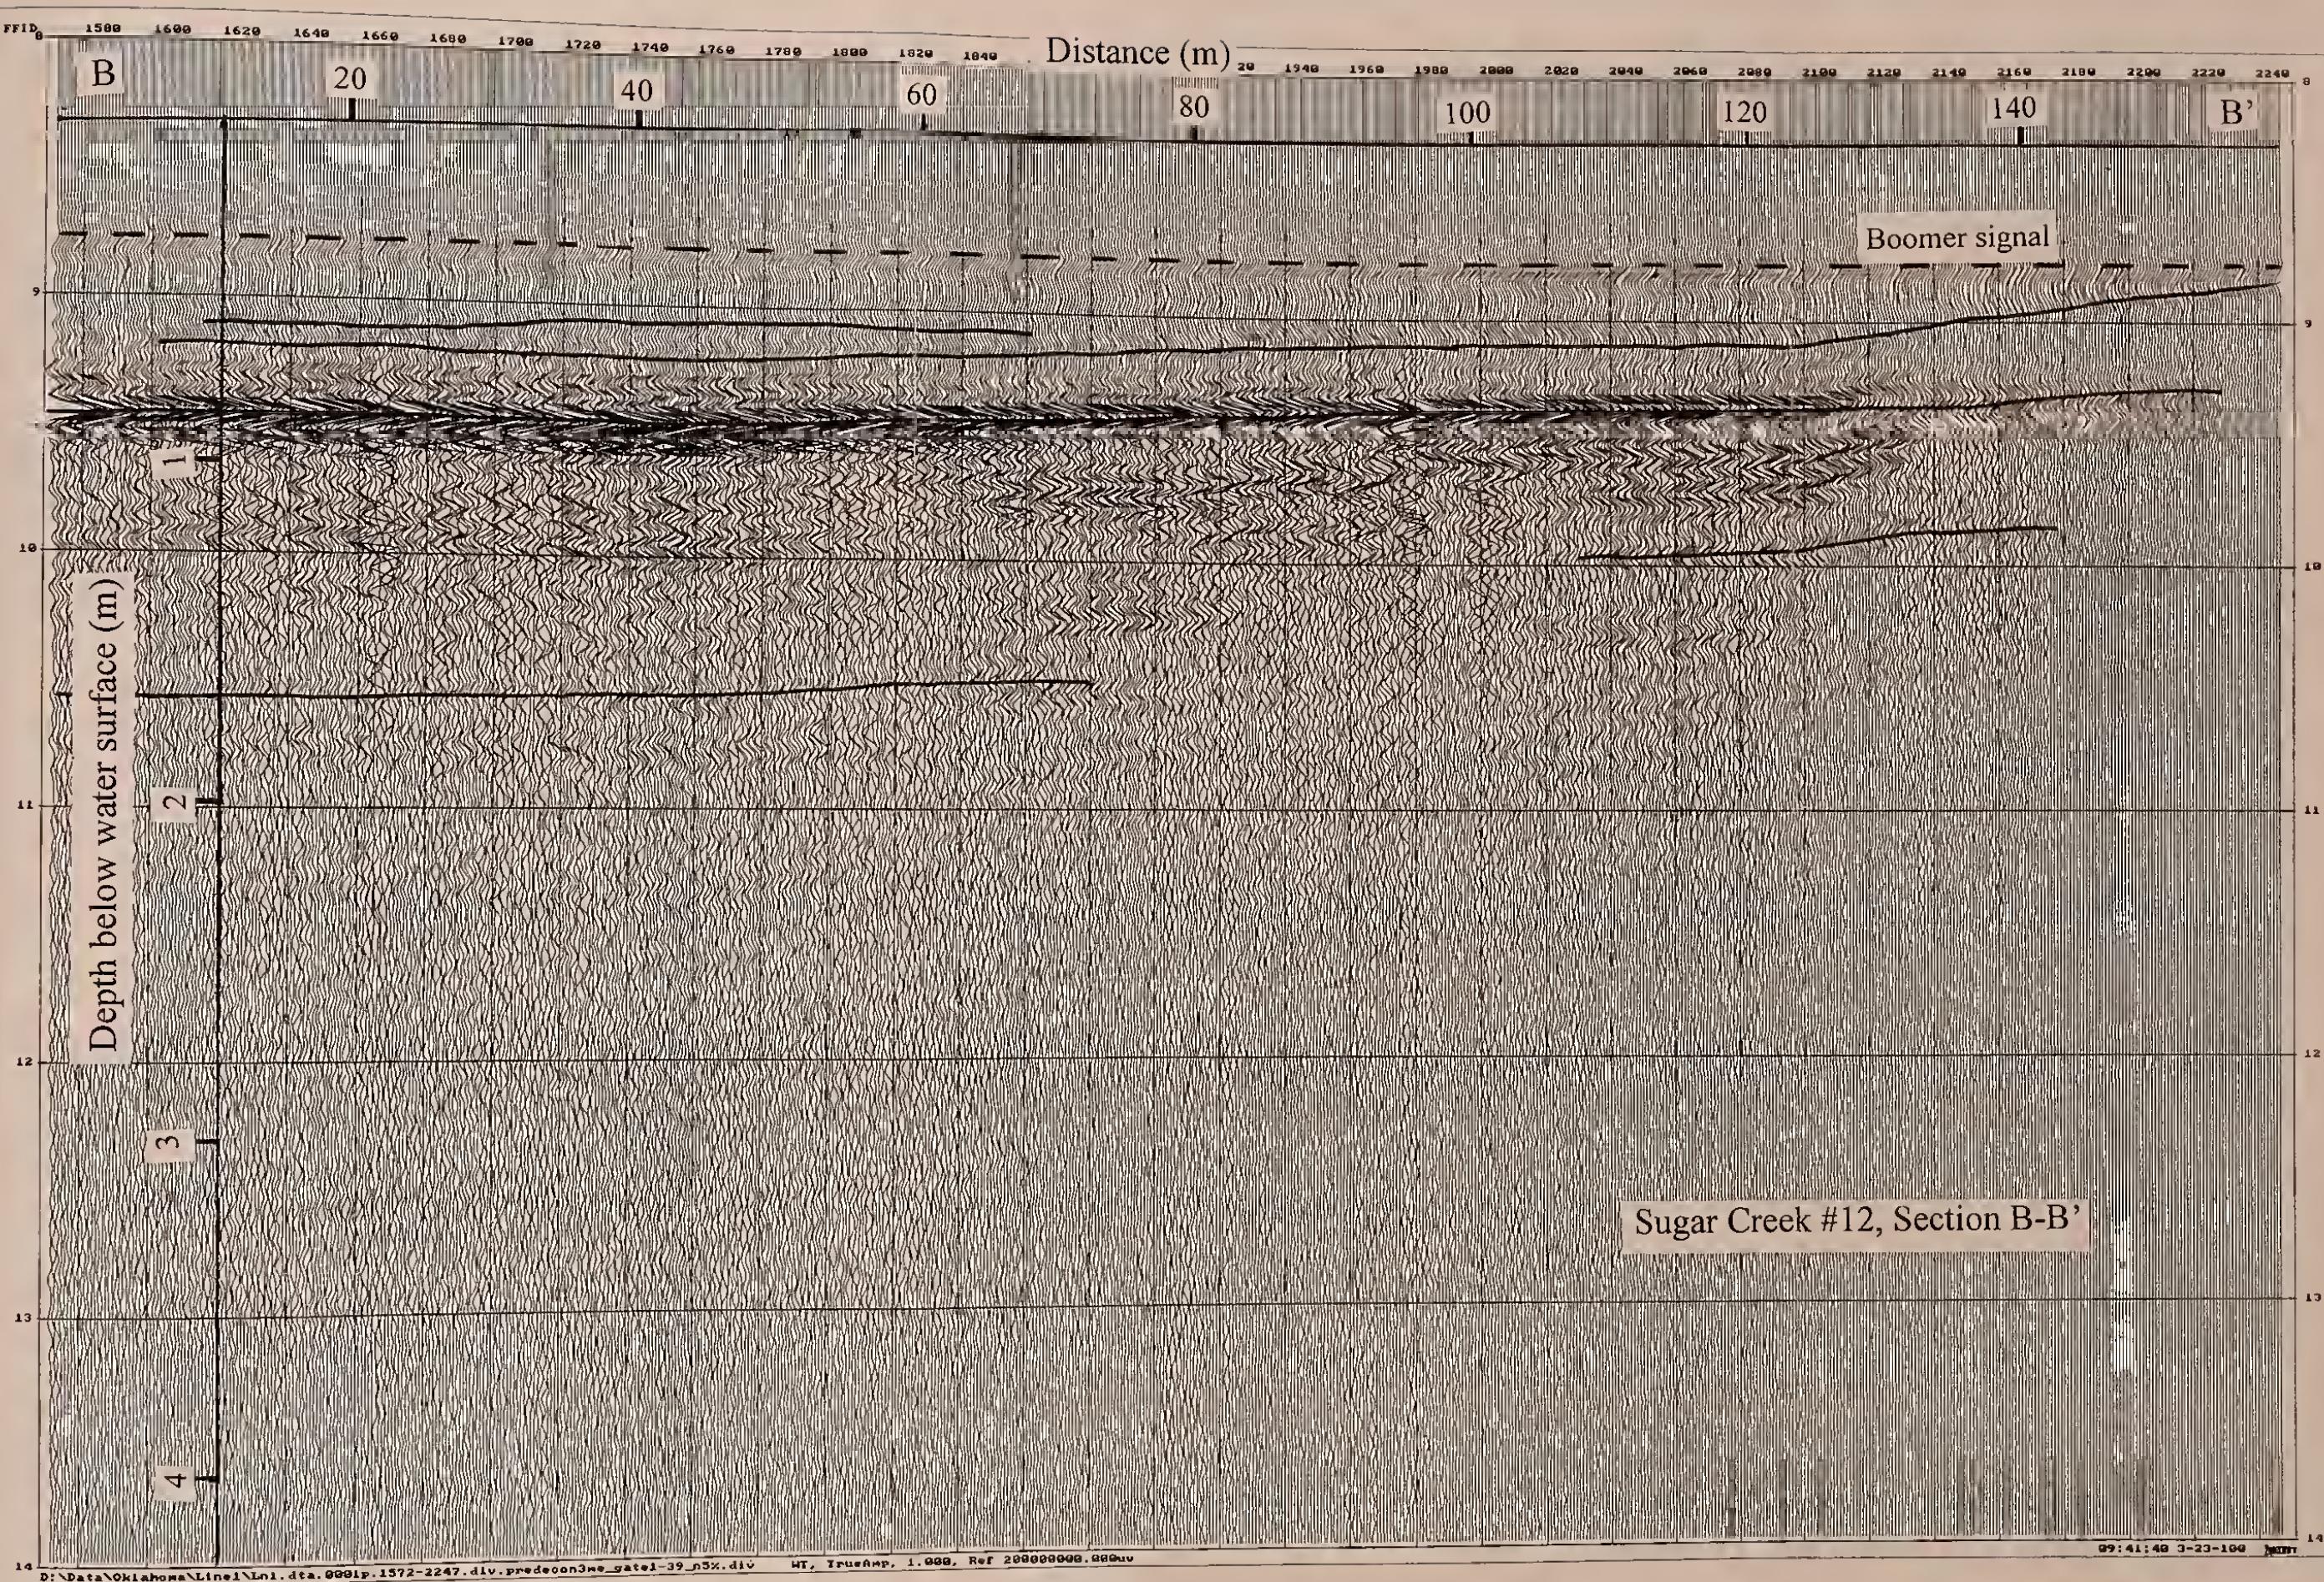
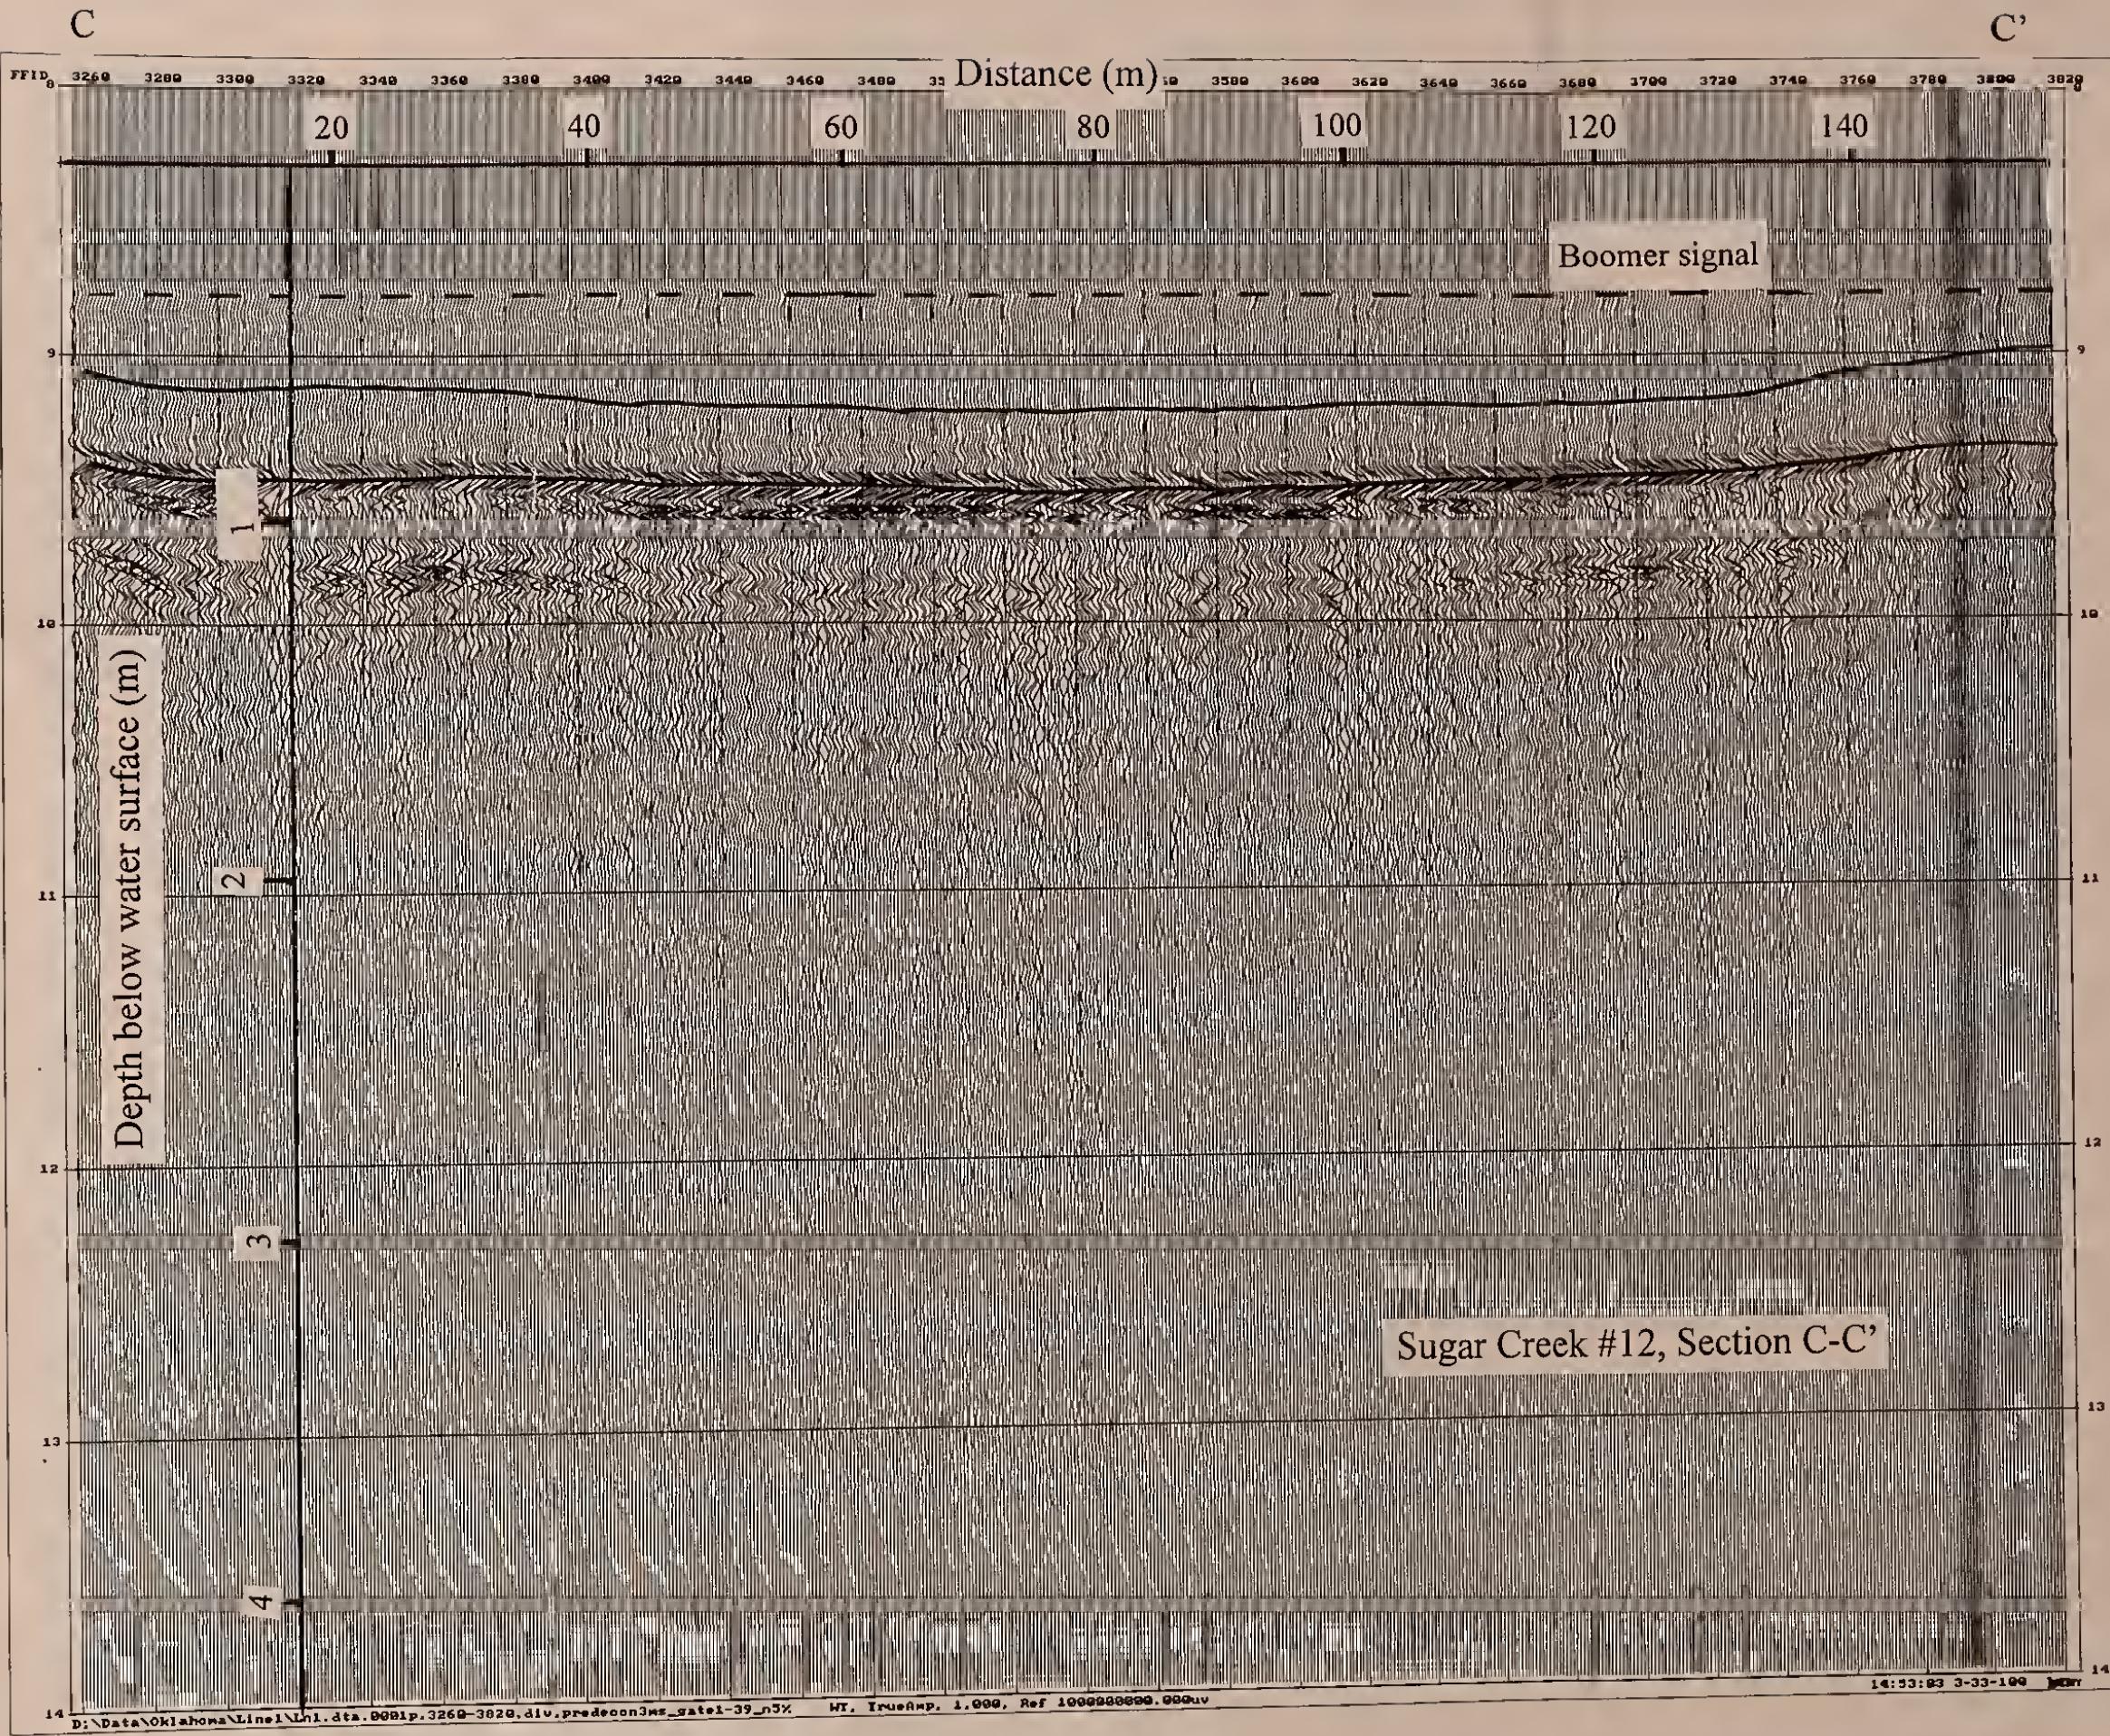
Figure 3-7. Seismogram of section B-B' from Sugar Creek #12 (next page; refer to Figure 3-5). Dashed line is location of boomer (approximately 0.5 m below the water surface), and solid lines are seismic reflectors identified. Depth and length scales are shown, and total length of seismic record is 158 m.

Figure 3-8. Seismogram of section C-C' from Sugar Creek #12 (next page; refer to Figure 3-5). Dashed line is location of boomer (approximately 0.5 m below the water surface), and solid lines are seismic reflectors identified. Depth and length scales are shown, and total length of seismic record is 156 m.

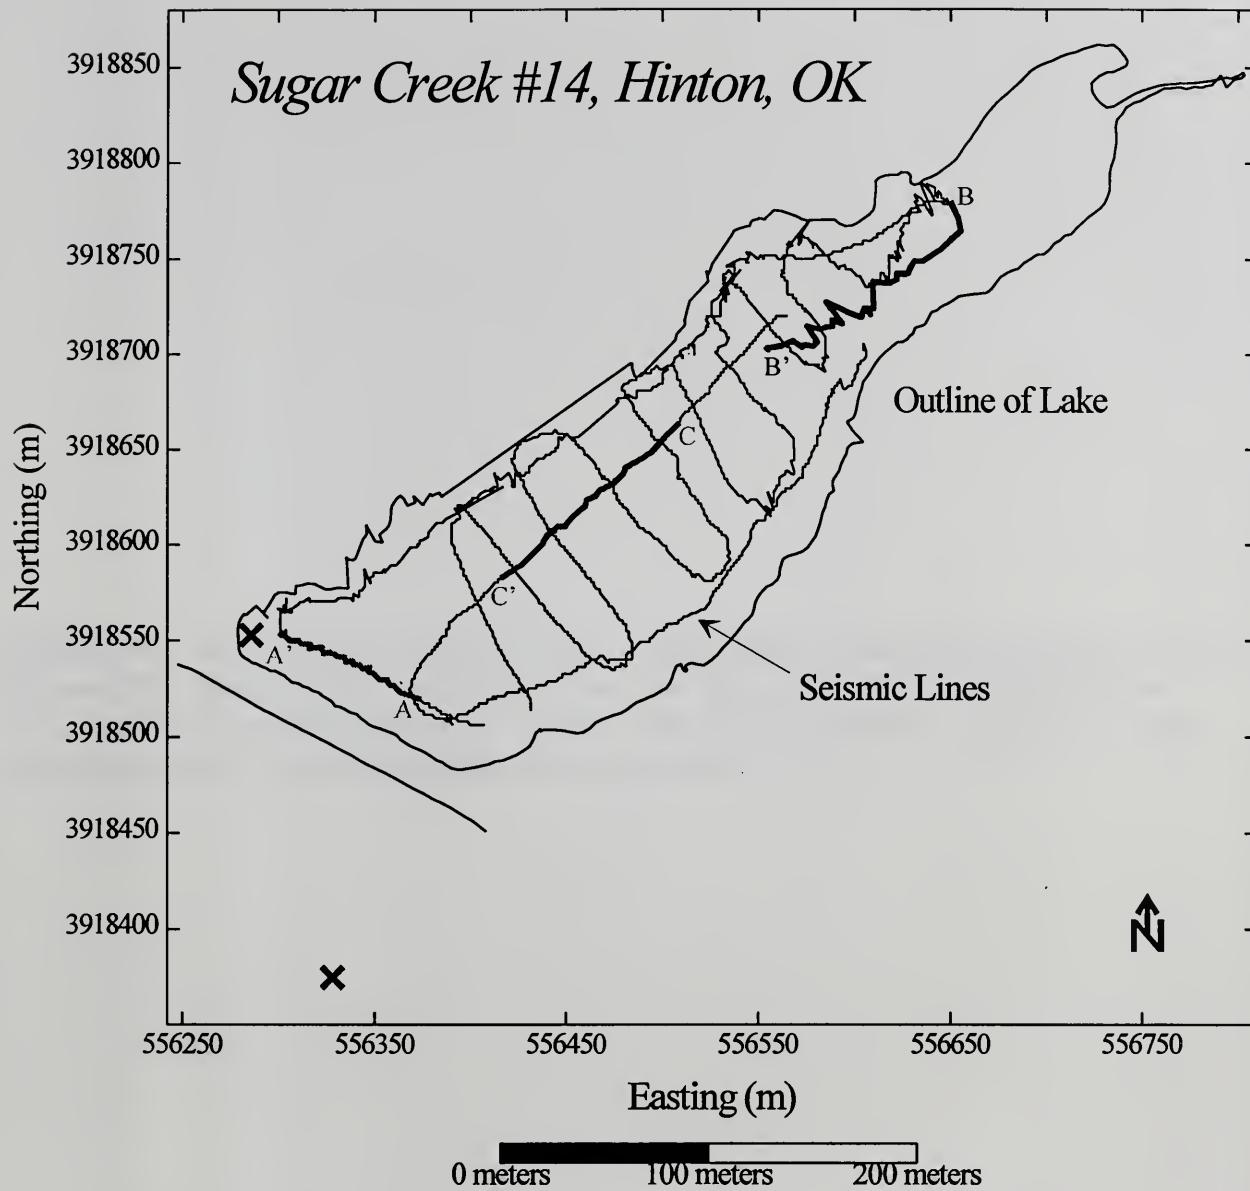
Figure 3-9. Base map of Sugar Creek #14 showing traces for all seismic lines. Three segments, labeled A-A', B-B', and C-C', are discussed in text. All positions are in UTM coordinates.

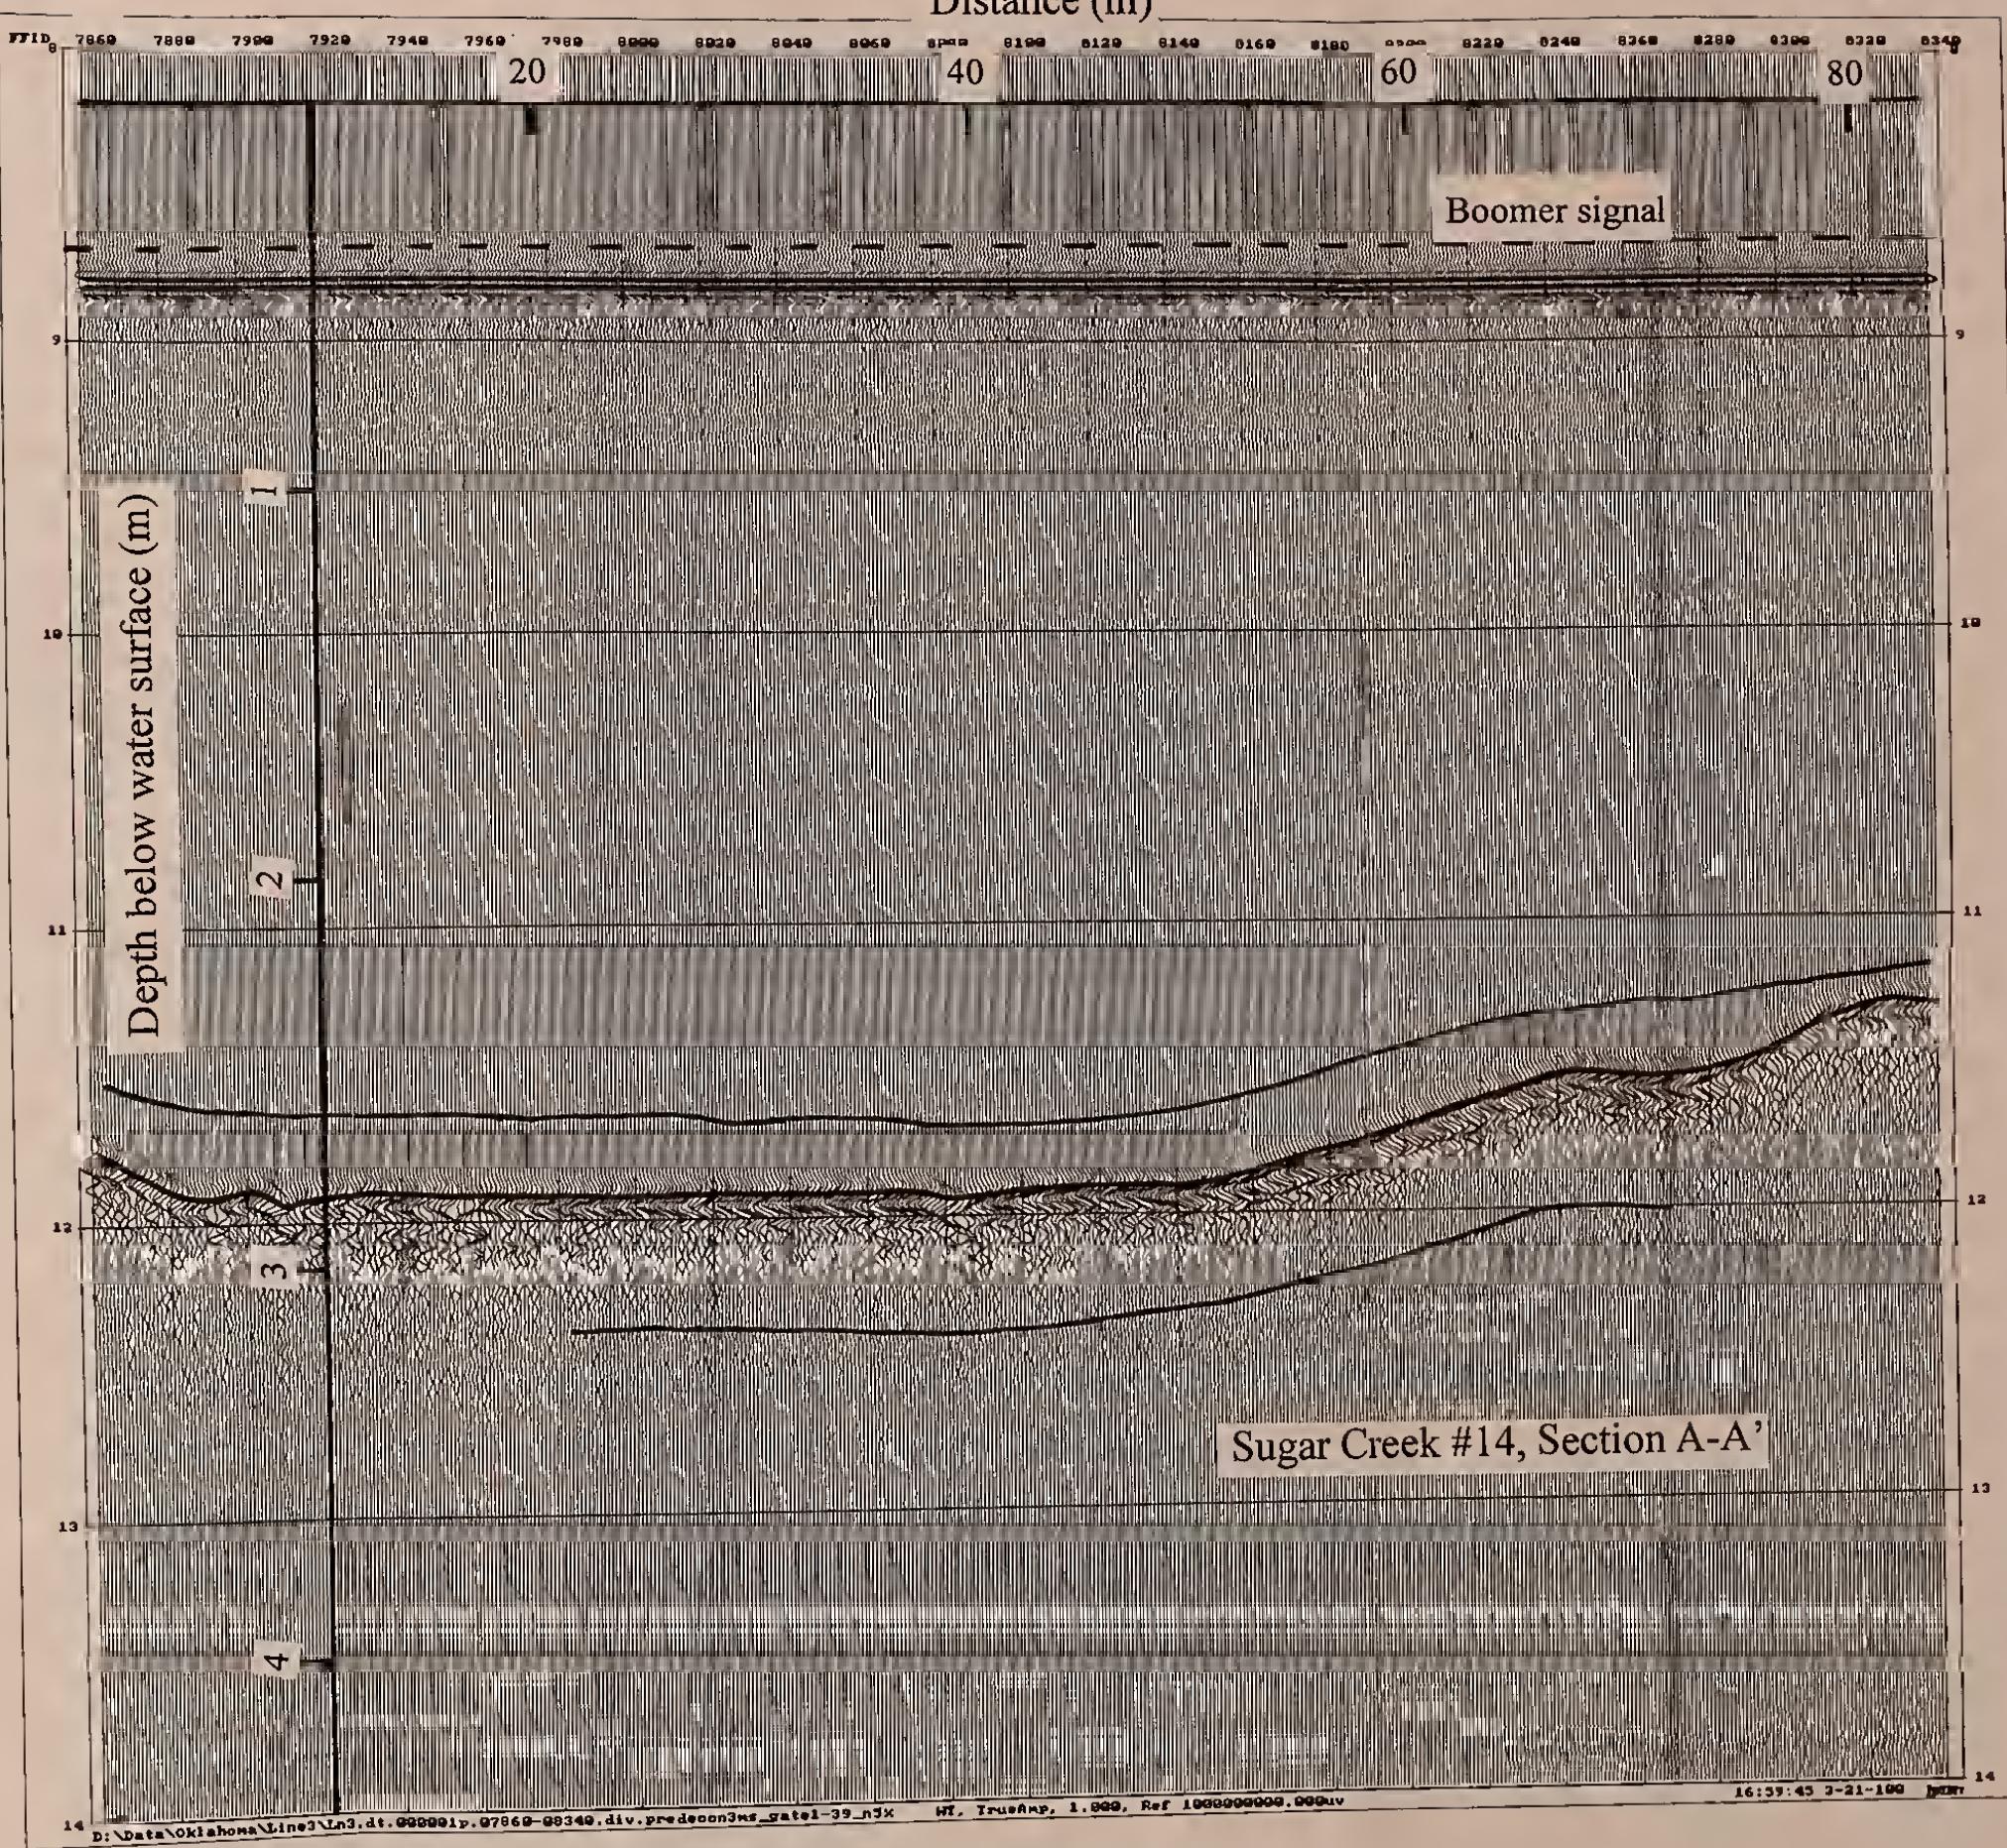
In general, the following observations can be made. The sediment near the water-sediment interface is quite soft, and it is represented by weak or low-amplitude reflectors, similar to Sugar Creek #12 (Figures 3-10, 3-11, and 3-12). This near-surface reflector is about 0.2 m thick, and it displays little variation in thickness across the basin. Some thinning of this unit occurs towards the principal spillway (towards A'; Figure 3-10). At a depth of approximately 0.2 m, a very strong seismic reflector is observed, and this reflector is ubiquitous in all the seismic records. This strong seismic reflector is similar in depth and character to the reflector observed at Sugar Creek #12, and the reason for its presence is still unknown. Few deep seismic reflectors were observed. But in Figure 3-10 and Figure 3-12, a reflector is observed at depths of 0.6 and 0.5 m, respectively, and the thickness of this reflector is about 0.3 m. At present, the reason for this deep reflector is unknown.

Figure 3-10. Seismogram of section A-A' from Sugar Creek #14 (next page; refer to Figure 3-9). Dashed line is location of boomer (approximately 0.5 m below the water surface), and solid lines are seismic reflectors identified. Depth and length scales are shown, and total length of seismic record is 84 m.
